**Debidue Beach
Year 3 Annual Survey**

**2025
MONITORING REPORT**

2025 YEAR 3 ANNUAL BEACH SURVEY DEBIDUE BEACH, GEORGETOWN COUNTY (SC)

[CSE 2566]
January 2026

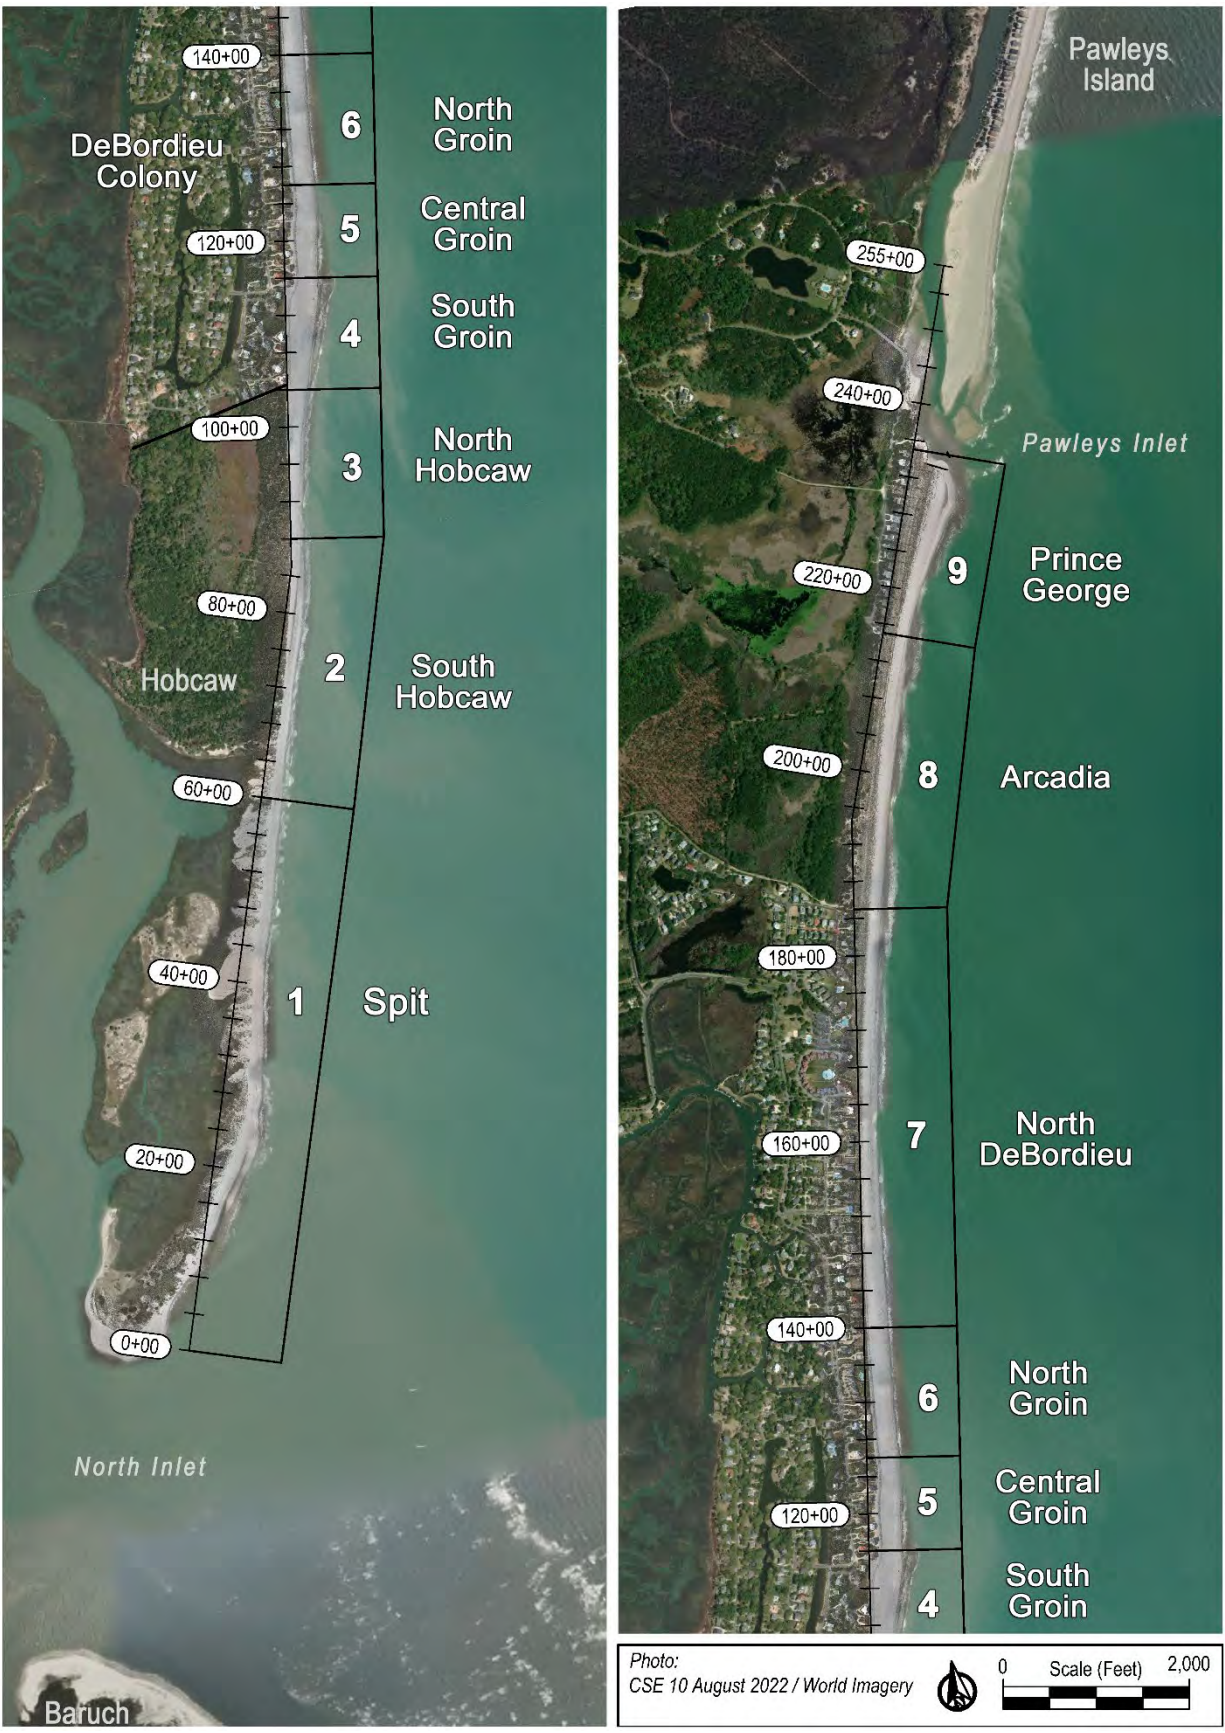
FIGURE 3.3. Station and Reach map for the DeBordieu Colony Beach Monitoring Program.

The South Hobcaw Reach (Reach 2) extends 2,800 lf between stations 60+00 and 88+00 (see Fig 3.3). It includes the southern portion of the beach fronting the upland/vegetated area north of the spit (Fig 4.7). It was identified as part of the monitoring area under SCDES-BCM’s permit conditions for post-project monitoring (along with Reach 3 – North Hobcaw). Multiple studies have documented erosion rates along the Hobcaw area (including Reach 3) to be at or greater than 10 cy/ft per year (ATM 2008, CSE 2017a).

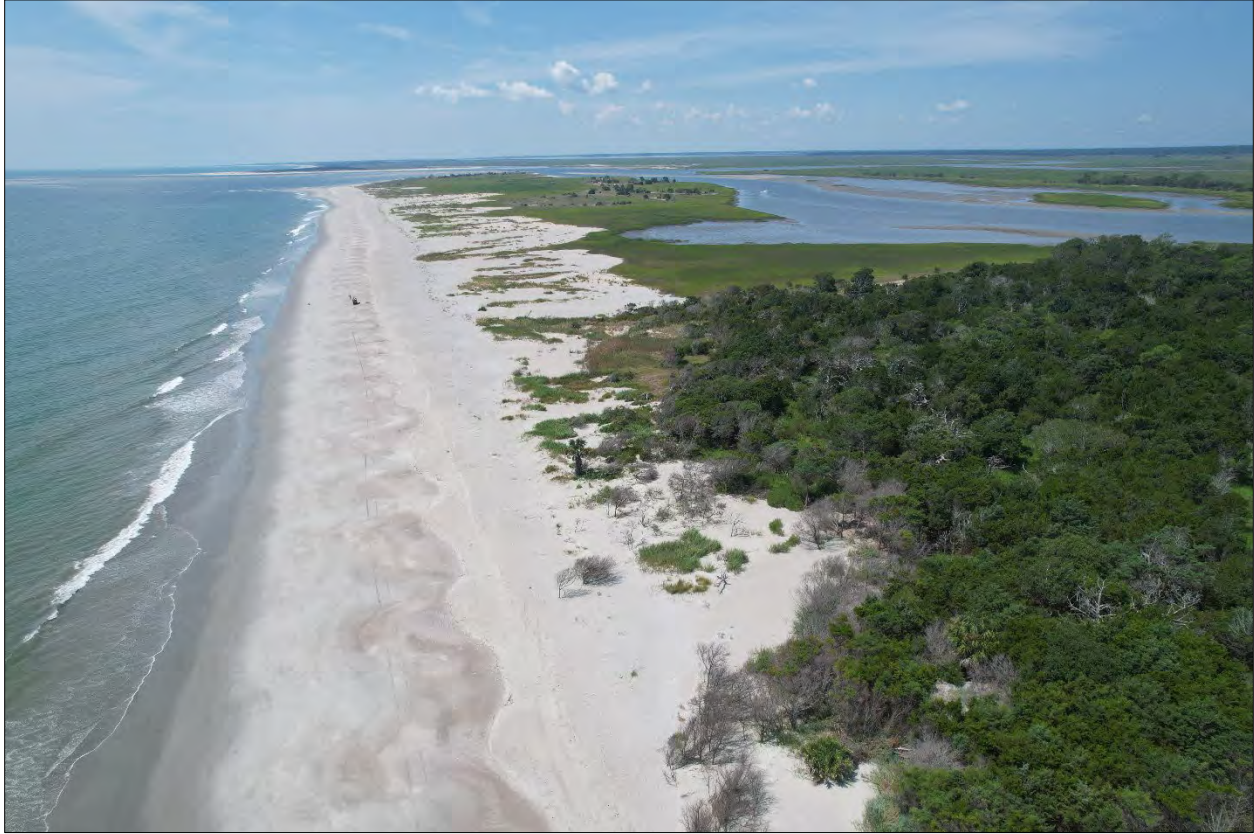
FIGURE 4.2. July 2025 aerial images of the south spit reach. Incipient vegetation is growing on the washover berm created during Hurricane *Ian* (30 Sep 2022). This area remains susceptible to breaching and overwash during storm events, despite this initial recovery following *Ian*'s impacts. Shoal attachment to Station 0+00 (lower).

The Spit Reach gained 17,000 cy of sand from January to May 2022 but has been moderately erosional since the project, losing a total of ~208,740 cy (–34.8 cy/ft) between May 2022 and July 2025. Losses were greatest from August 2022 to October 2022, when Hurricane *Ian* overwashed the area, and from June 2023 to January 2024, due to the impact of a pair of nor'easters. Erosion was initially greater along the northern half of the reach from May 2022 through October 2022, but has shifted such that the greatest losses from June 2023 to July 2025 occurred along the southernmost ~2,000 lf (Fig 4.4). However, the southernmost end of the reach has gained sediment due to periodic shoal attachments (fig 4.2).

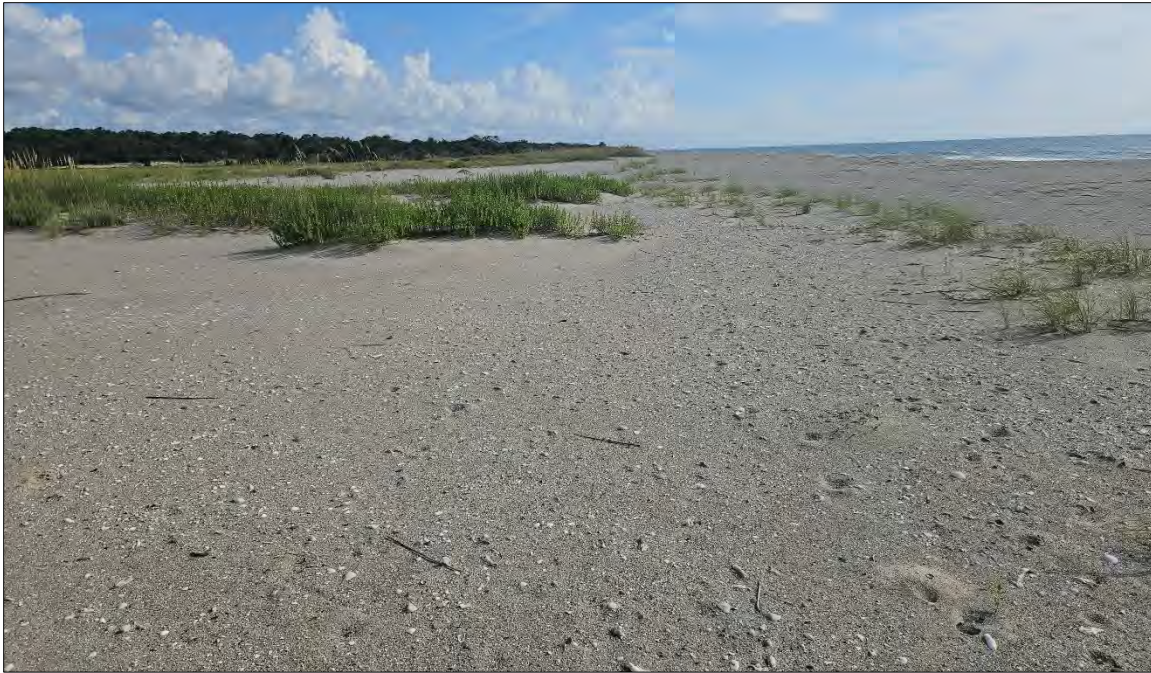
FIGURE 4.6. The low overwashed spit south of the Hobcaw Tract along the northern portions of Debidue Spit is exceptionally low and narrow as of July 2025 (shown in image above). A future breach is highly likely in the next few years and will represent a major shift in ‘natural’ background patterns of sediment transport along this portion of Debidue Beach.

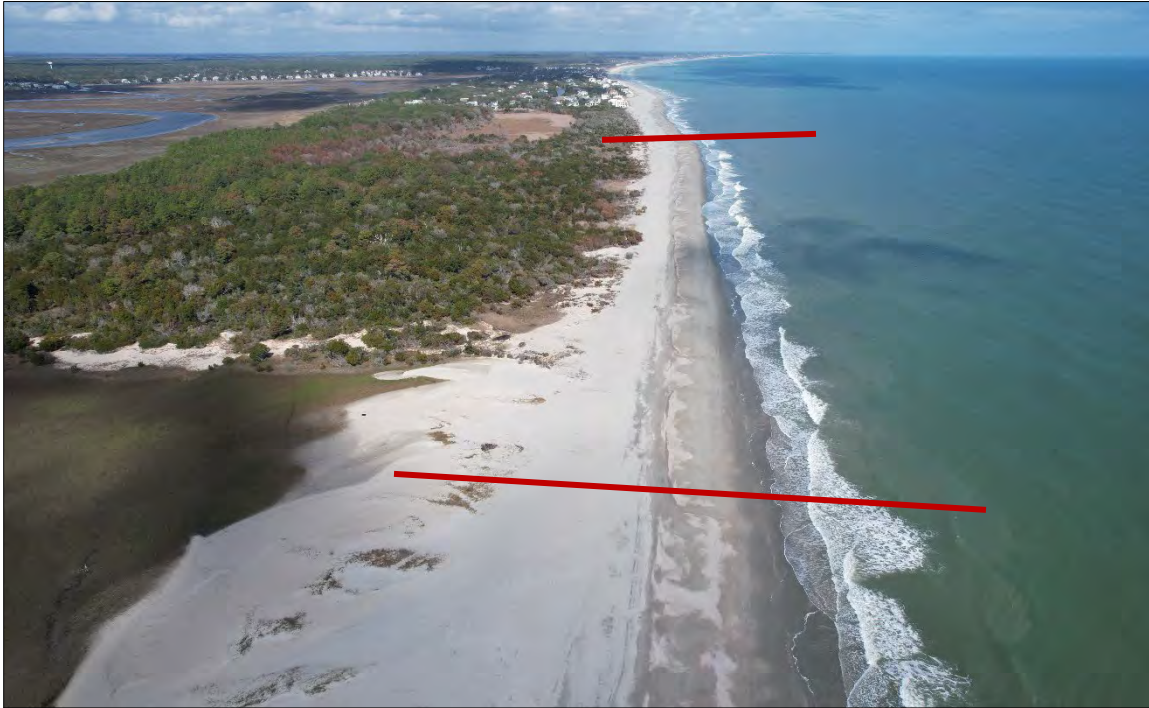
FIGURE 4.7. The South Hobcaw Reach extends from the northern end of Debidue Spit (foreground) to approximately 1,700 ft south of the southernmost groin (highlight).

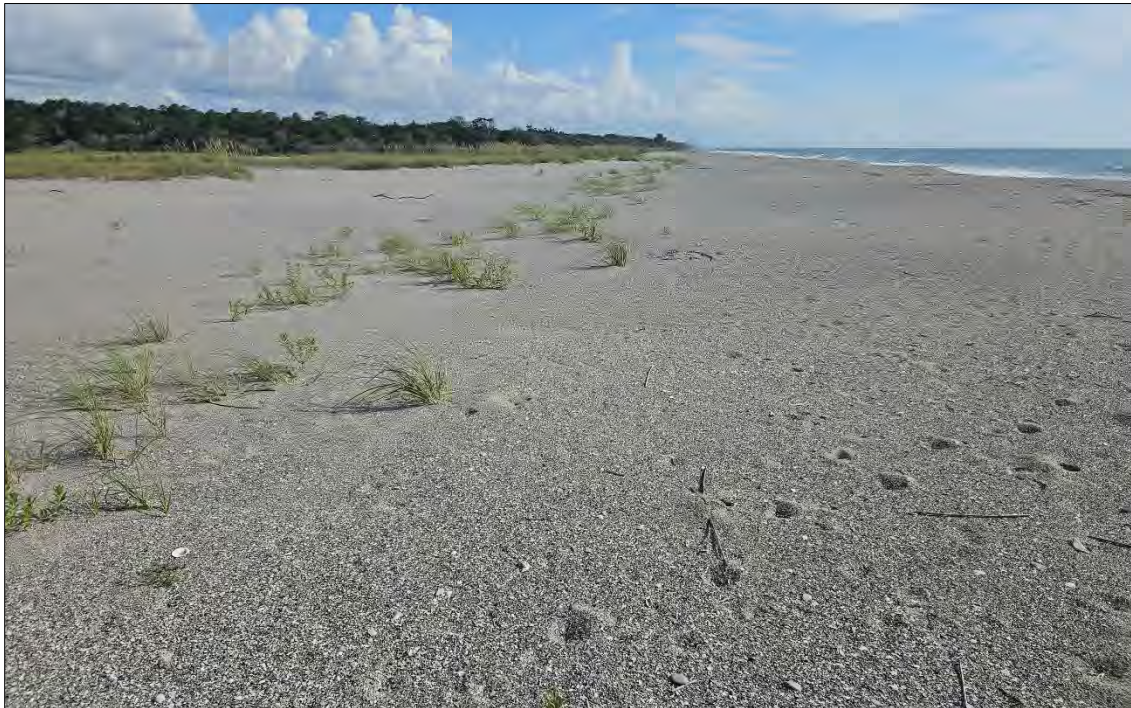
FIGURE 4.9. Overwash in the vicinity of Station 60+00 reduced the foredune crest elevation from ~12 ft NAVD in May 2022 to ~7 ft NAVD as of July 2025. This portion of the island is susceptible to continued overwash during future storm events, and may breach in the next several years. Such a change would be the result of natural background erosion and shifting hydraulics around North Inlet, rather than any acute impacts from the Debidue project.

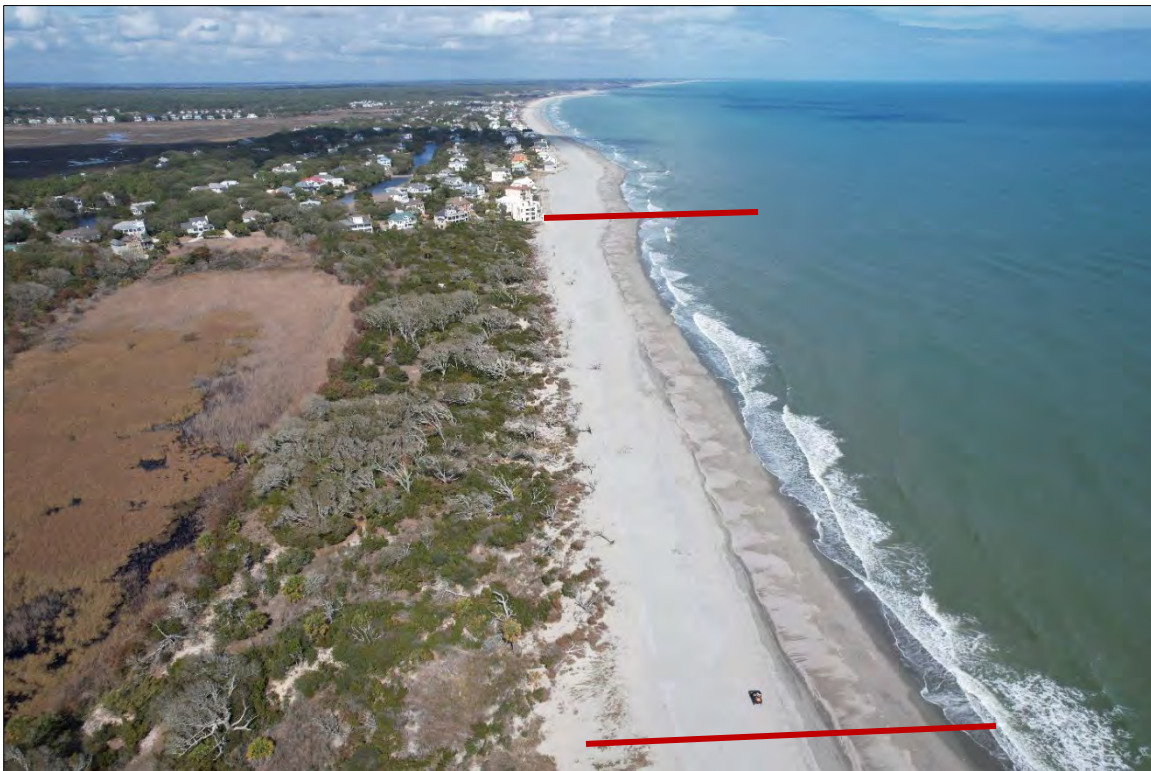
FIGURE 4.10. The North Hobcaw Reach extends from the central portion of the Hobcaw Tract (approximately 1,800 ft south of the southernmost groin) to the southernmost groin (highlight).

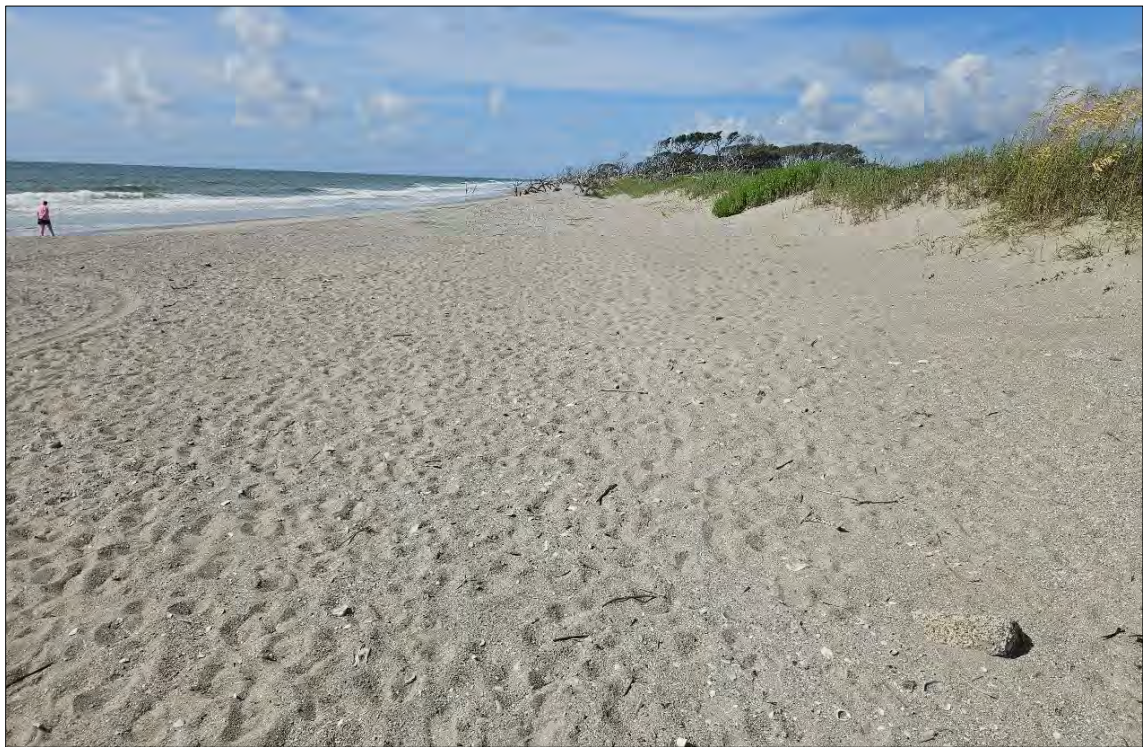
FIGURE 4.12. Beach widths along North Hobcaw remain considerably larger than the pre-project condition (January 2022, above) and continue to hold steady at ~100 ft wider as of July 2025.

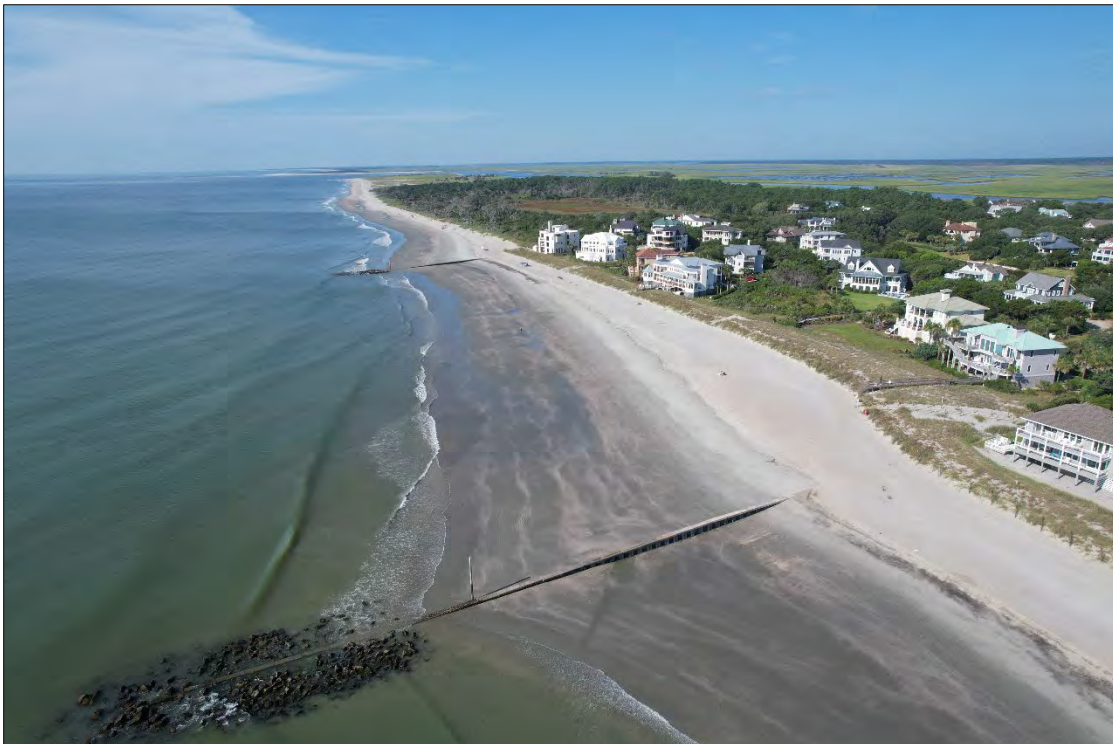
FIGURE 4.13. Reach 4 extends from the southernmost groin (background) to the central groin (foreground).

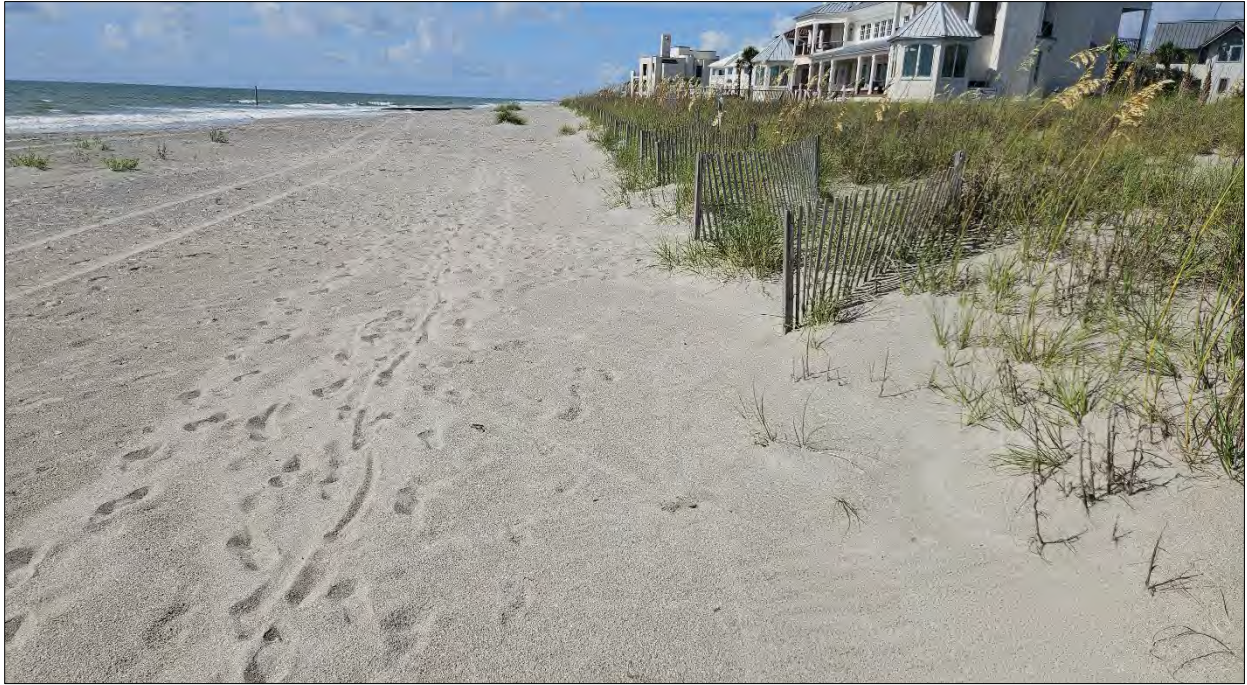
The constructed dune withstood a nor'easter in January 2024. In addition, DCCA-sponsored plantings in spring 2023 have successfully accelerated dune growth (Fig 4.16). These changes enhance the resiliency and habitat function of the dune ecosystem in this area, which is a significant improvement over the pre-project conditions when this reach was primarily backed by a timber bulkhead.

FIGURE 4.16. July 2025—Dunes showing robust health and resilience following DCCA planting efforts.

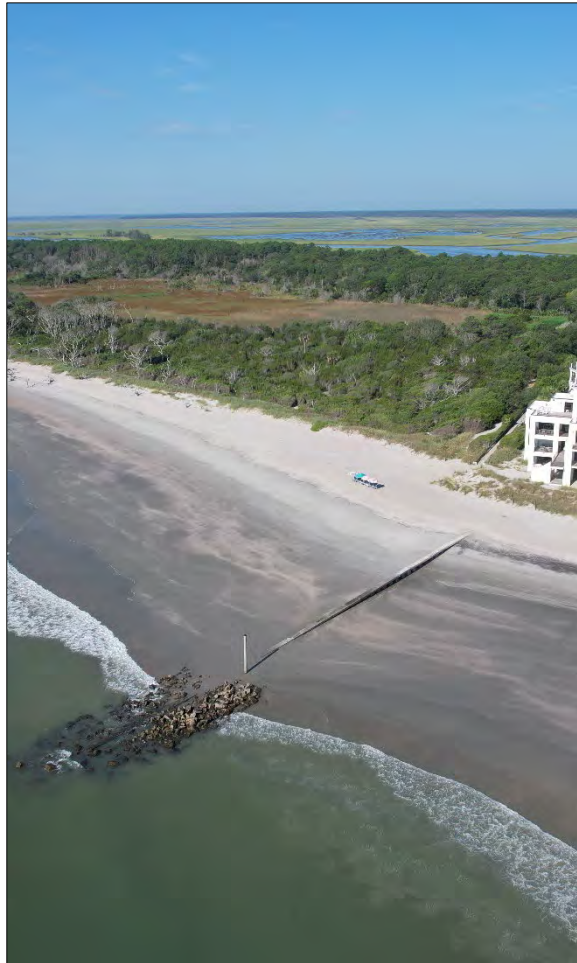
Groin #3 became more exposed in 2025, with most of the slope section cap visible. (Fig 4.17). No discernible fillet was present to suggest a dominant sediment transport direction, indicating that more sand is present in the area than the groin is capable of trapping. At Groin #2, most of the structure is exposed, including the seaward portion of the berm section. Vertical exposure was up to ~3 ft, with higher exposure on the south side of the groin. (Fig 4.18). A slight asymmetry in the MLW contour at Groin #2 suggests northerly (south-to-north) sediment transport around July 2024.

FIGURE 4.17. Groin #3 oblique aerial, July 2025. Much of the structure exposed above MLW.

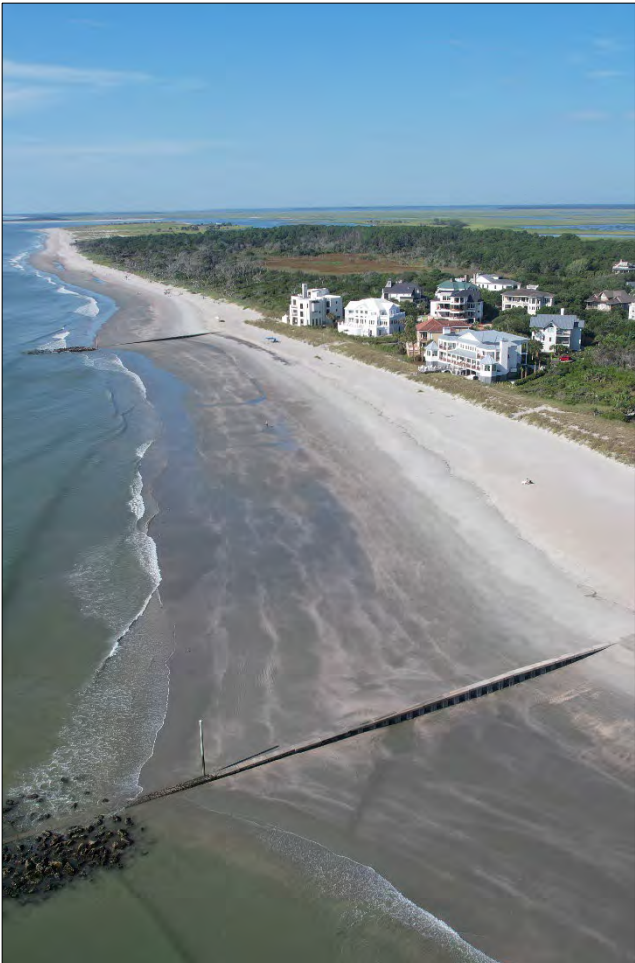
FIGURE 4.18. Groin #2 oblique aerial, July 2025. Much of the structure exposed above MLW.

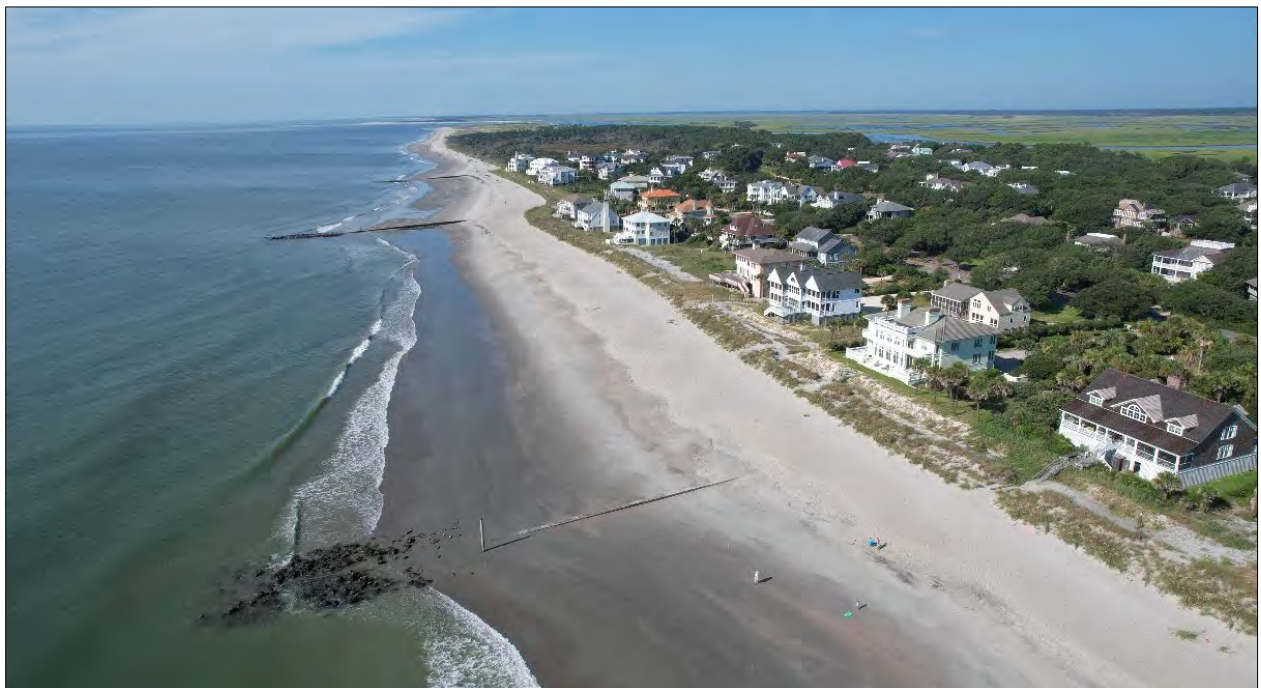
The 2022 project added ~171,800 cy (171.8 cy/ft) of sand to the reach. More sand was placed near Groin #2 due to the need to create a wider sand platform for construction and the critically eroded condition of the beach. Nourishment included a dune with a crest elevation of +13 ft NAVD that buried the seawall by a minimum of 2 ft. The dry beach width increased by approximately 300 ft during nourishment (before fill adjustment), and remains 100 to 150 ft wide as of July 2025 (Fig 4.19).

FIGURE 4.19. Reach 5 extends from the central groin (background) to the northernmost groin (foreground).

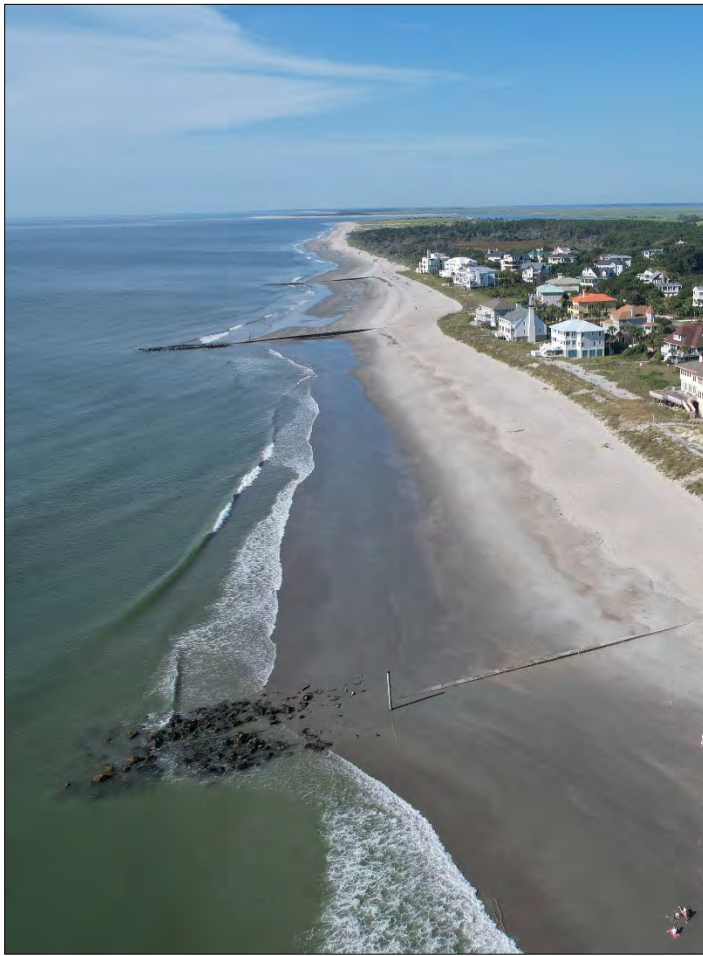
Profiles show that sand has shifted higher along the berm, and the dune experienced significant growth in 2025 as sand fencing accumulates wind-blown sand along the toe of the dune. (Fig 4.20 upper). This has flattened the slope of the beach closer to the pre-project condition (Fig 4.20 lower). As of July 2025, all of the cap sections of Groin #1 were exposed above MLW (Fig 4.21).

FIGURE 4.21. Groin #1 oblique aerial, July 2025. Much of the structure remains buried above MHW, allowing beach access alongshore at all tides.

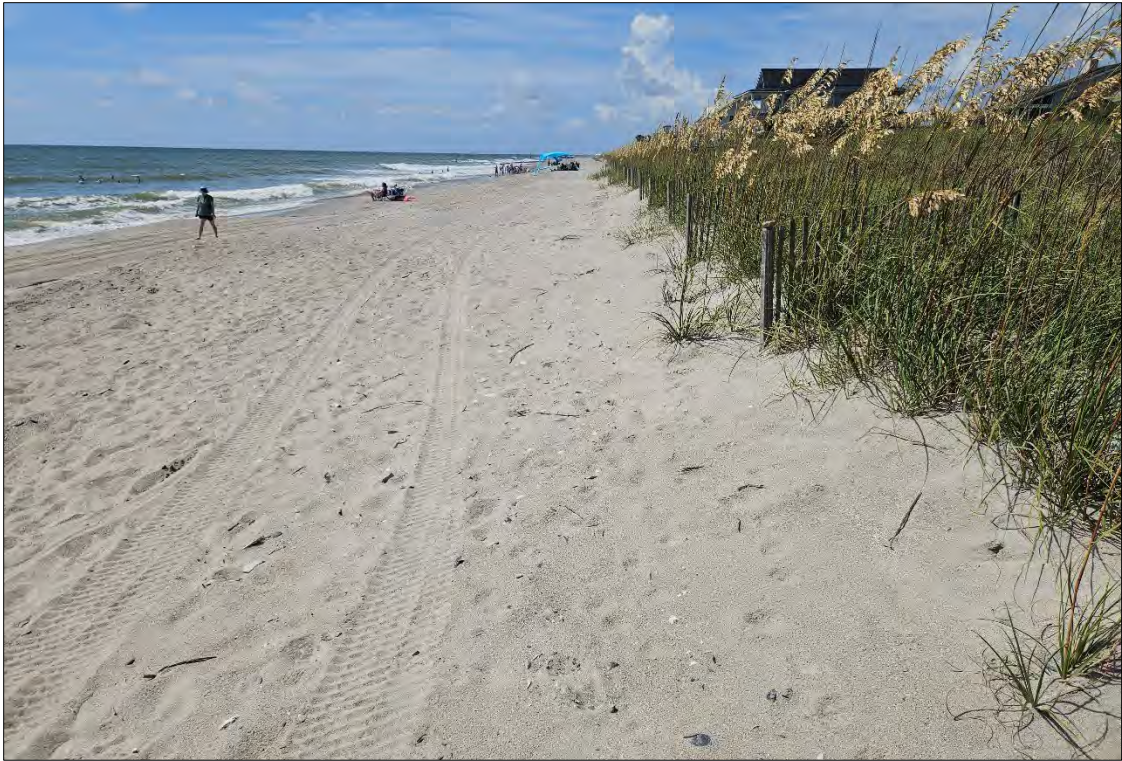
Reach 6 lost a total of ~16,330 cy (-11.7 cy/ft) of sand in Year 3. It currently holds 91,060 cy (65.0 cy/yr) more sand than the pre-project condition and retains 61% of the nourishment fill. The reach was fairly stable during Year 3 compared to the other two groin reaches. Ground photographs taken in July 2025 document vegetation recovery following Hurricane *Ian*, which at least momentarily exceeded the foredune crest elevation between the center and north groins (Fig 4.23 upper).

FIGURE 4.23. Beach widths remain significantly higher along Reach 6 than the pre-project condition as of July 2025, which should help these grasses re-establish naturally over the next couple of years.

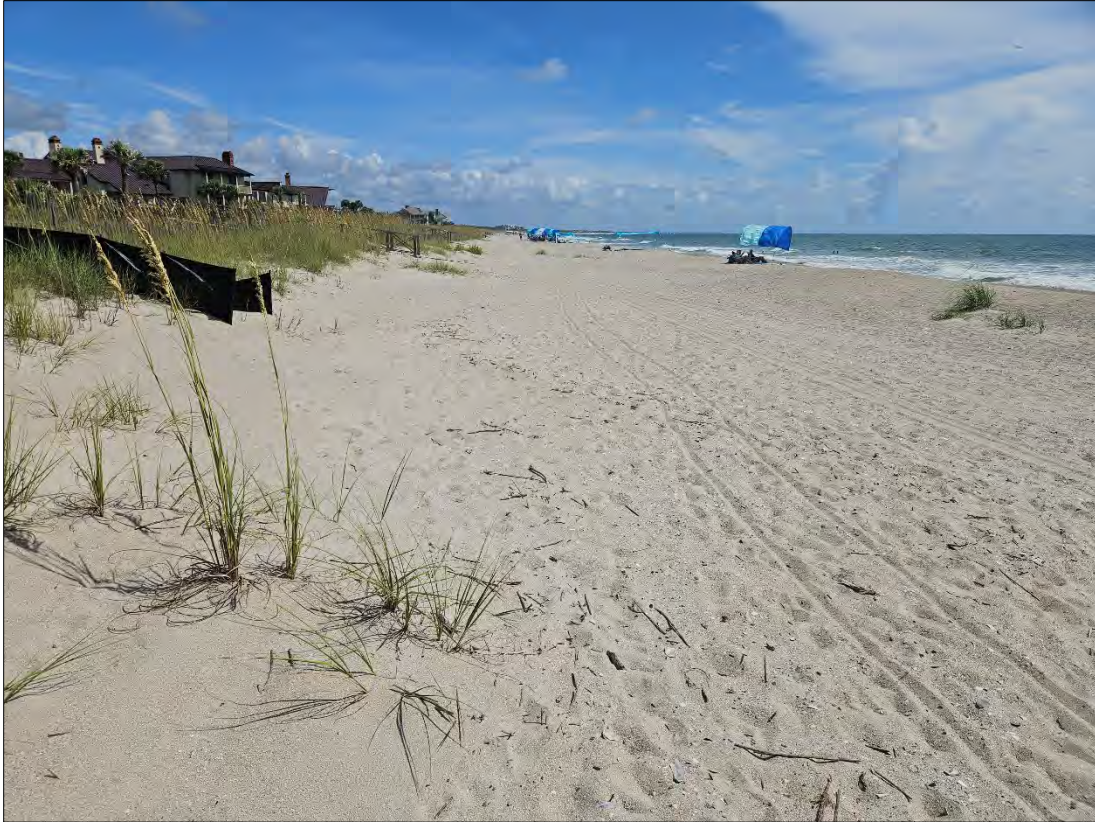
From July 2024 to July 2025, the reach lost 33,080 cy (–7.4 cy/ft). The reach has lost ~36,670 cy (–8.2 cy/ft) relative to the post-project condition. There is still 54,350 cy (12.1 cy/ft) more sand than the pre-project condition (60% of the nourishment sand remains) (Fig 4.25).

FIGURE 4.25. Ground photograph looking north taken in July 2025 at Station 165+00, along with profile showing pre- and post-project elevations at this location.

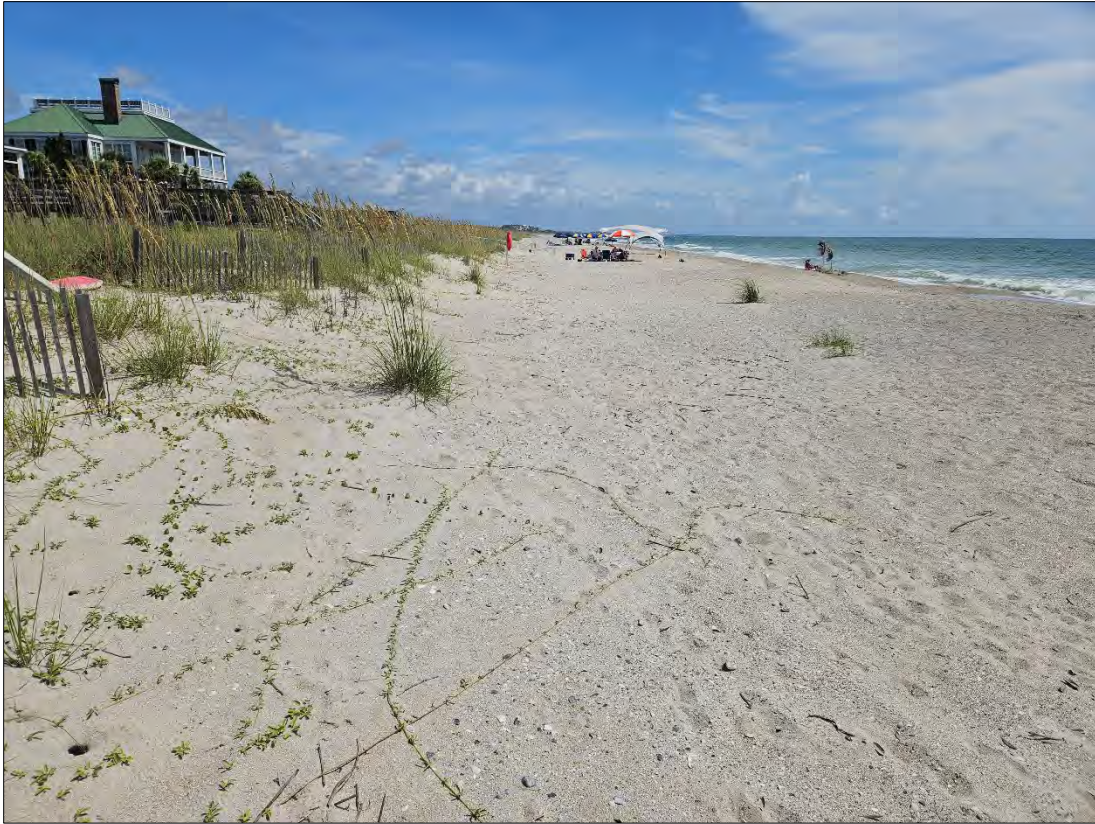
FIGURE 4.26. Ground photograph looking north at Reach 7, taken in July 2025 at Station 180+00, along with a profile showing pre- and post-project elevations at this location.

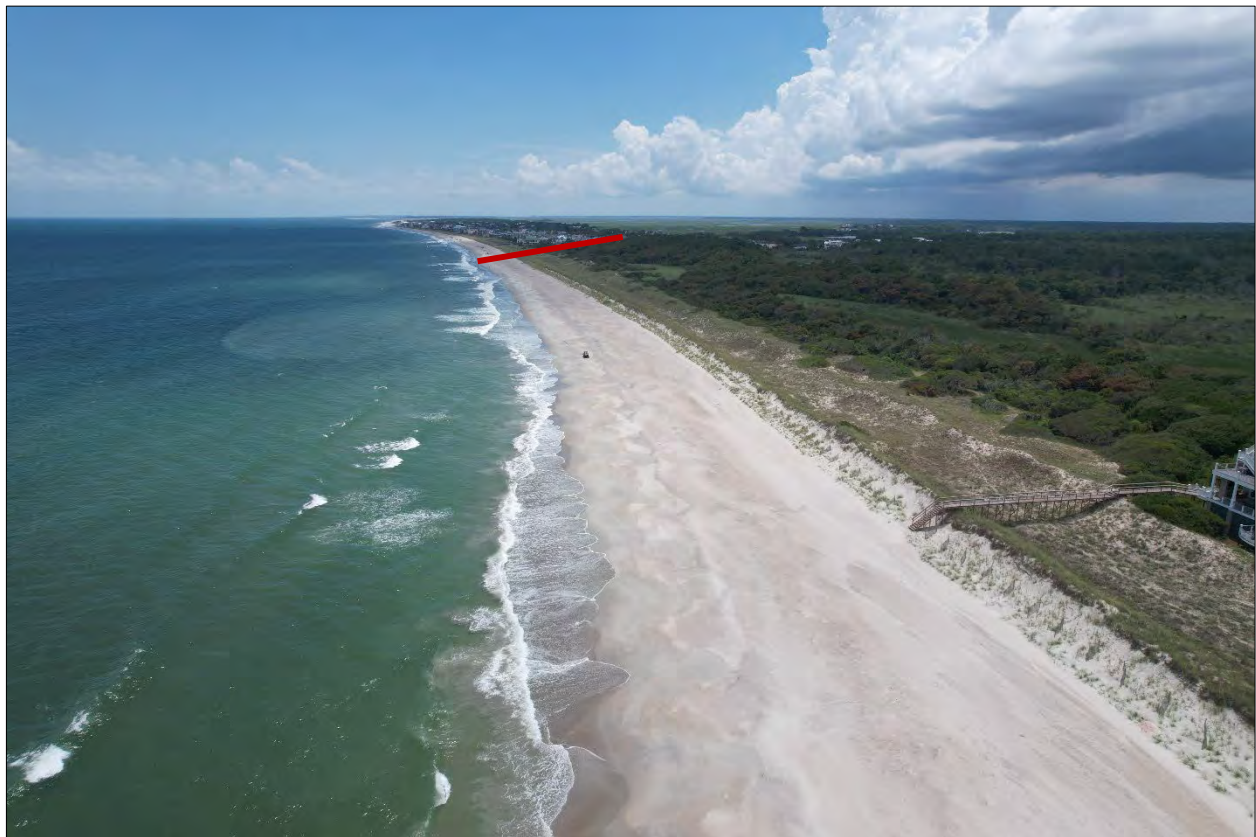
FIGURE 4.27. Reach 8 extends from the north end of the fill template (background, highlight) to Station 215+00 (foreground).

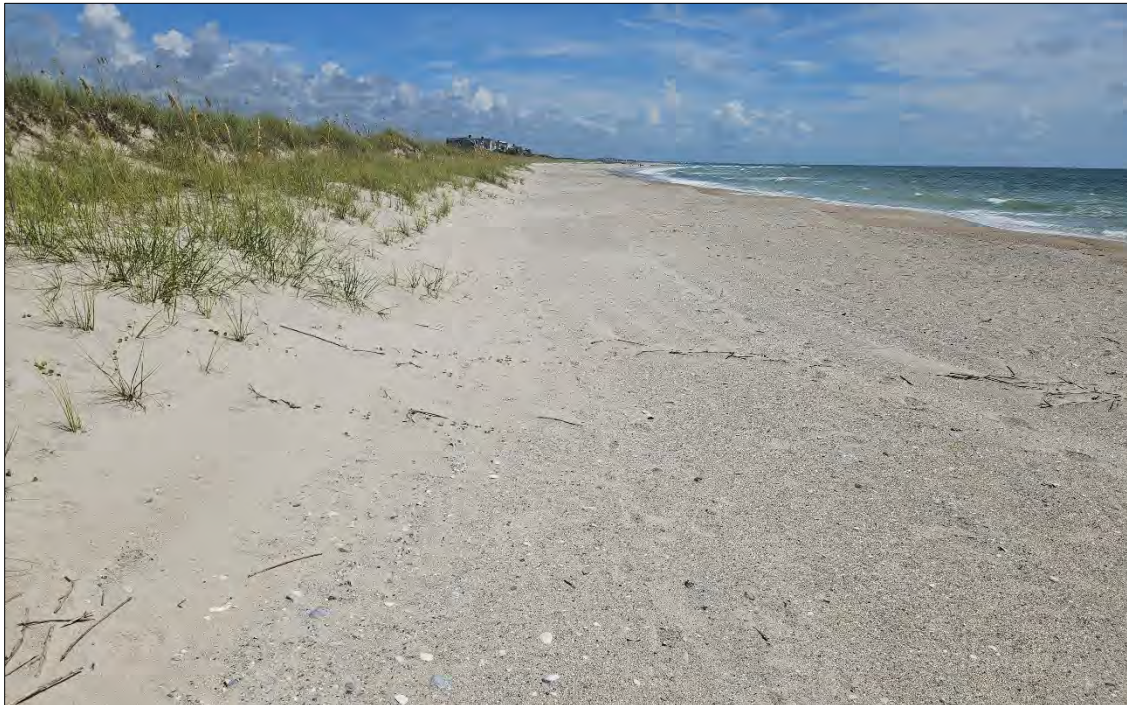
FIGURE 4.28. Ground photograph looking north in the middle of Reach 8 taken in July 2025 at Station 200+00, along with profile showing pre- and post-project elevations at this location.

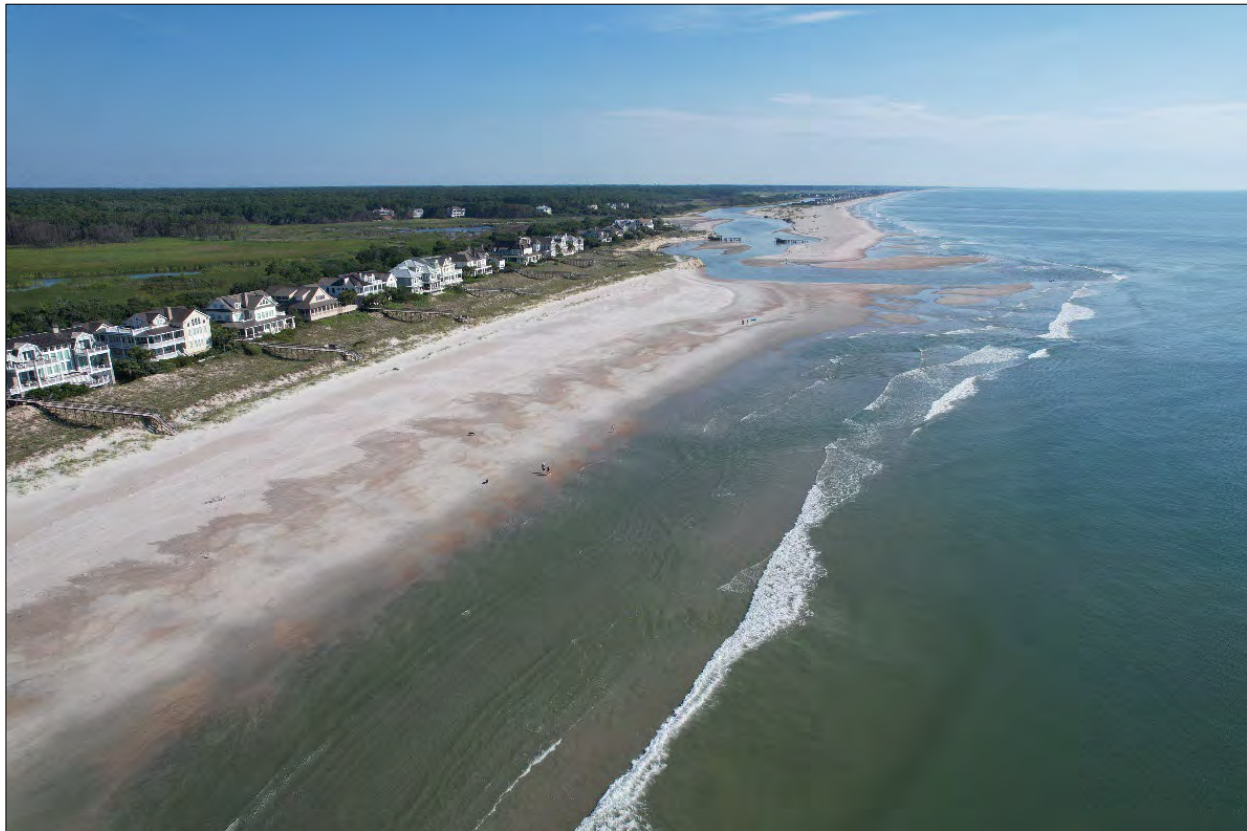
FIGURE 4.29. Reach 9 extends along the developed portion of the Prince George Tract from the southernmost structure (foreground left) to Pawleys Inlet (background right). As of July 2025, Pawleys inlet had moved south into the developed portion of Prince George.

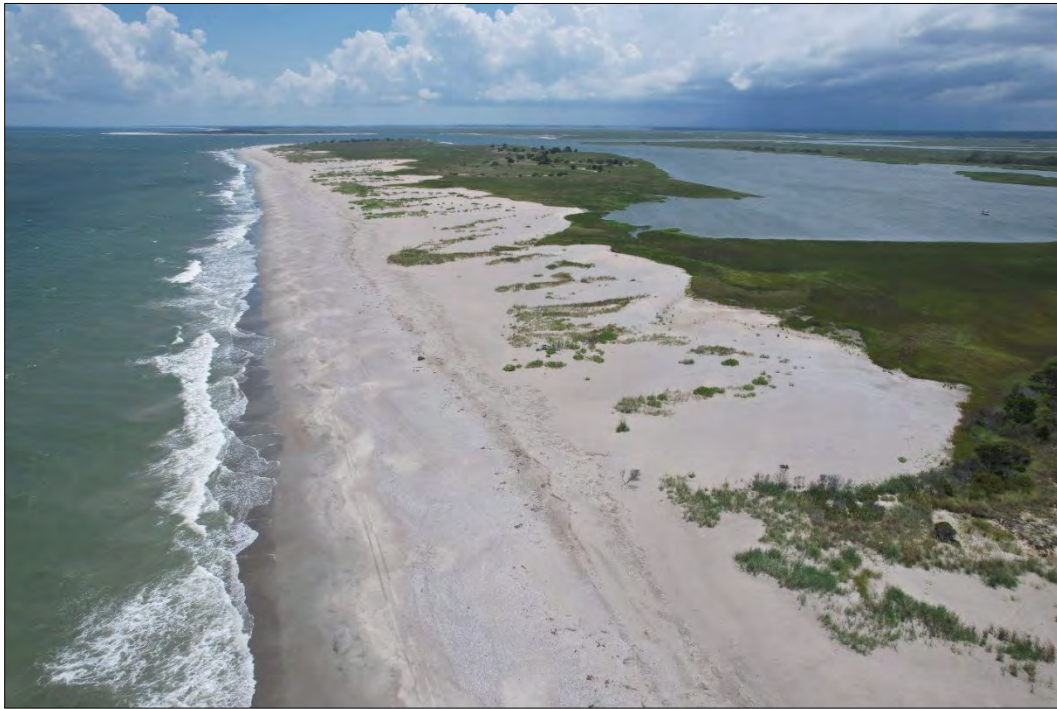
FIGURE 7.2. A naturally occurring overwash area at the south end of the Hobcaw Tract is actively drawing sand off the beach and influencing year-to-year erosion rates along the southern end of the groin monitoring area of the project.

Annual measurement of the 2.05 ft NAVD contour is required in early summer each year and will be compared to a survey taken within one month before the beginning of the project. The pre-project survey was in January 2022; the same month work began on the groins. The Year 3 rate measured in July 2025 was -0.3 acres per year (Table 7.1). The position of the 2.05 ft NAVD contour from January 2022 (pre-project), Year 1 (June 2023), Year 2 (July 2024), and Year 3 (July 2025), shown in Figure 7.1, demonstrates that there has been no excessive erosion caused by the project along the Hobcaw Tract since project completion. Rather, the erosion observed along the southern Hobcaw Tract is a result of the natural overwash just south of the area, which has a tendency to shift the MHW contour landward (Figure 7.2).
